Manhole Inspection Summary

Manhole # S13G1_001MH

Insp Date: **5/18/09 12:36 PM**

Location Address: **S CATON AV**

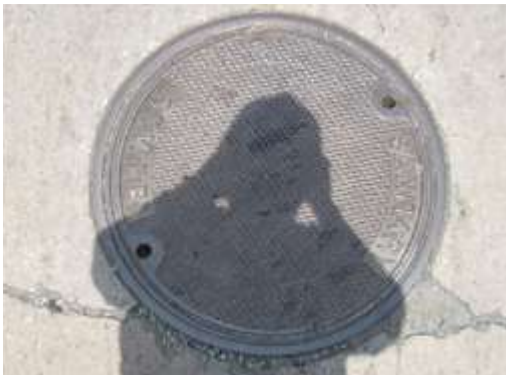
Miscellaneous

COVER PIC

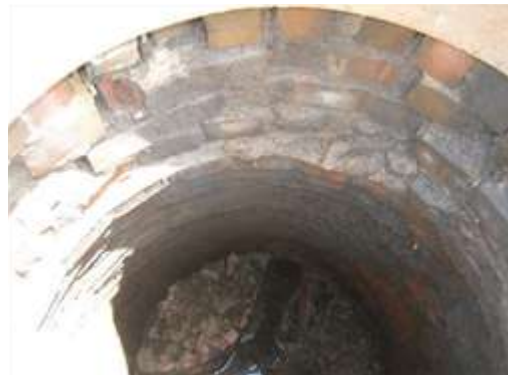
Miscellaneous

Condition: ☐ Sound ☒ **Cracked** ☐ Root Intrusion ☒ **Loose Brick** ☐ Deteriorated

chimney @ 12 Oclk

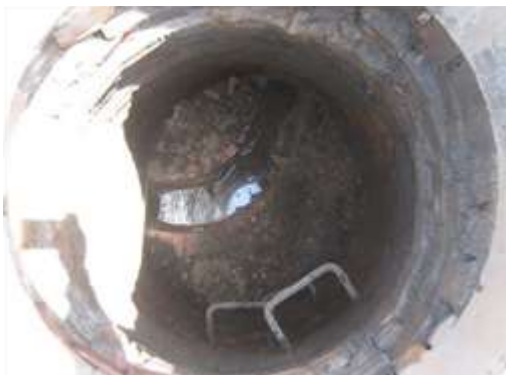
Defect 5

Steps Count: **3** Missing: **0** ☒ **Corroded**

Corroded Steps

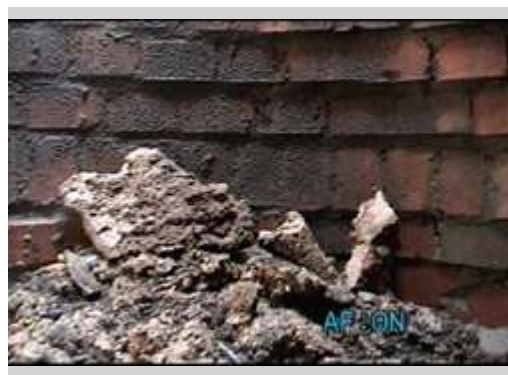
Defect 4

Condition: ☐ Sound ☐ Cracked ☐ Root Intrusion ☐ Deteriorated ☐ Leaks ☒ **Debris**

DEBRIS on bench

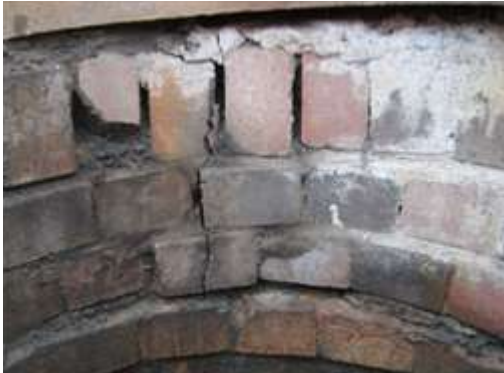
Defect 3

CRACKED CHIMNEY/BARREL

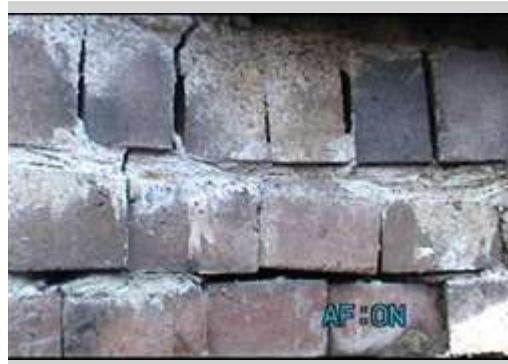
Defect 2

MISSING MORTAR

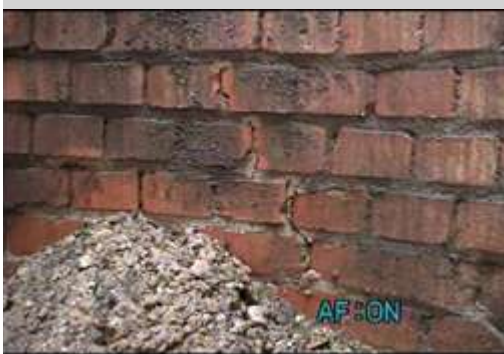
Defect 1

Condition: ☐ Sound ☒ **Cracked** ☐ Root Intrusion ☐ Loose Brick ☐ Deteriorated

CRACKED WALL BARREL AREA

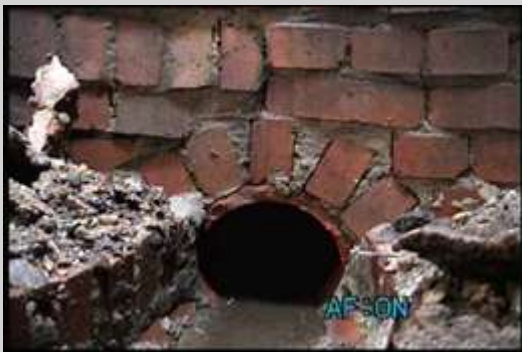
12 O'Clock Outflow

8 in. Circular Gravity Sewer
Pipe Out @ 12 O'Clock

Pipe Height: **8.4** (in.) Rod and Bar (Angled)
Pipe Material: **Clay** ☐ Pipe Lined
Invert Depth: **9.14** (ft.) Flow Characteristics: **Slow**
Deposits: ☒ None ☐ Mud ☐ Sludge ☐ Debris ☐ Grease
Silt Depth: **0** (in.) Deposits Extent:
Infiltration: **None** Pipe Seal Cond: **Sound**

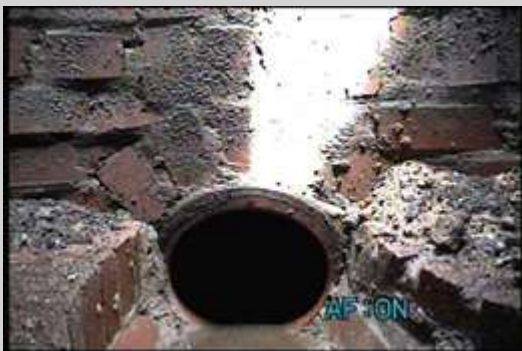
8 O'Clock Inflow

8 in. Circular Gravity Sewer
Pipe In @ 8 O'Clock

Pipe Height: **8.4** (in.) Rod and Bar (Angled)
Pipe Material: **Clay** ☐ Pipe Lined
Invert Depth: **9.12** (ft.) Flow Characteristics: **Slow**
Deposits: ☒ None ☐ Mud ☐ Sludge ☐ Debris ☐ Grease
Silt Depth: **0** (in.) Deposits Extent:
Infiltration: **None** Pipe Seal Cond: **Sound**
